Bladerider – Trouble Shooting

Last Update - July 1, 2009

7.1 Hydrofoils and Adjustments

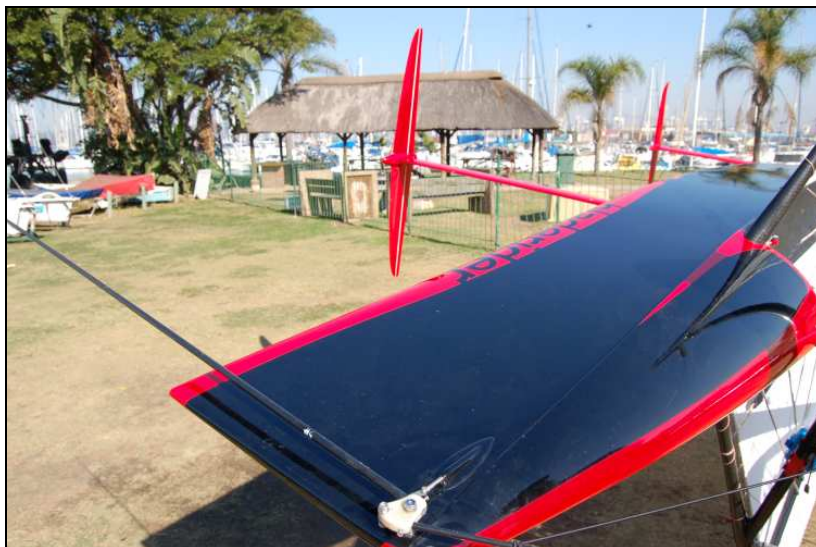
If there is little or no resistance in the wand linkages, then push the wand as far forward as possible. The wand should be perpendicular (or slightly forward of perpendicular) to the bow of the boat (as per photo below), and the flap should be in the 'fully up' position.

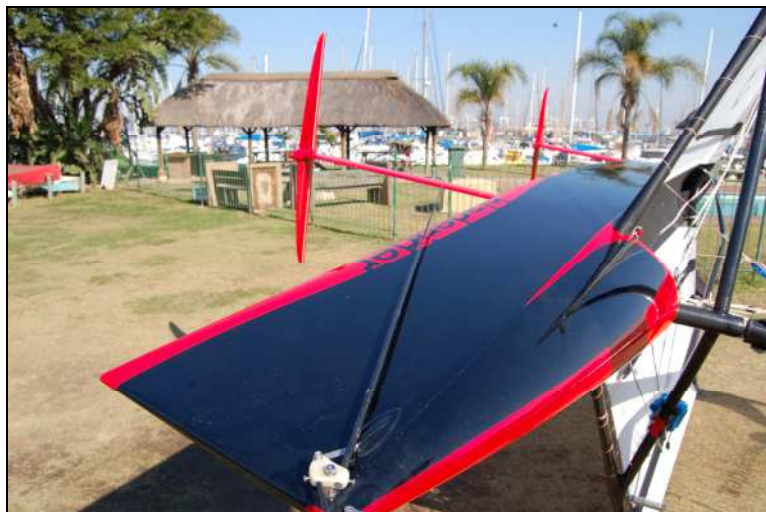
The first thing to check is if the wand can be pushed back passed the letters 'er' in the signage 'Bladerider' on the side of the hull (or be past 60 degrees to the bow as per photo below). If this is the case, then when the boat is sailing in displacement mode (low-riding and hoping to fly) with the wand at around 60-45 degrees to the bow, then the front flap is not pushed down enough and consequently does not give you enough lift to take off. Therefore you can fix this on water by simply winding out the ball/socket joint head at least two more turns at a time to give you more lift.

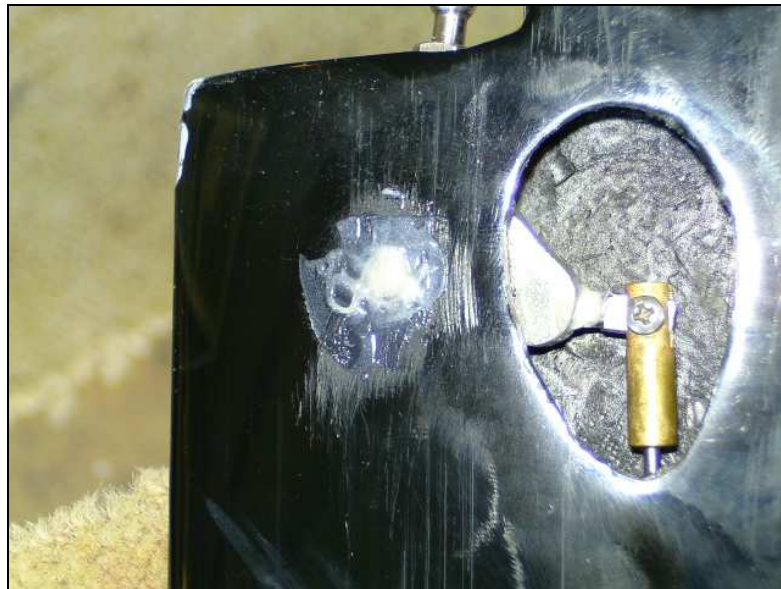
7.1.10 Bell Crank Axle is Loose in Centerboard

If the stainless steel axle at the top of the centerboard for the Bell Crank is unwinding itself when sailing or is loose inside the hole, then you will urgently need to glue in the axle on both sides to the centerboard, using ONLY epoxy glue with filler additive (only use 5 minute epoxy in emergencies).

Once the glue is set hard (after 24 hours), you will need to file/sand off any excess glue that will prevent the centerboard from being inserted into the centerboard case. There should no need to remove this axle in the future once your setup is correct, however it will be possible to cut it out if necessary.

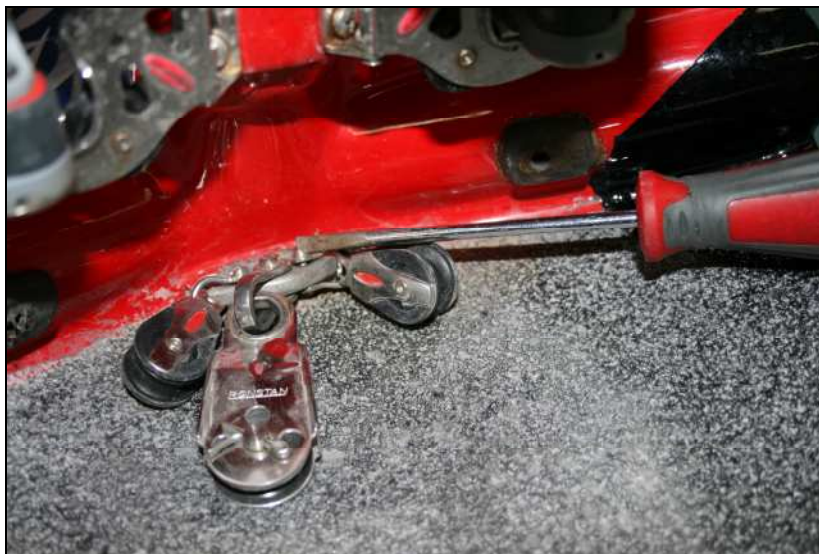
7.4.2 The Small Vang Shackle on the Starboard Side is always coming loose

This happens because the shackle pin was not tight enough to begin with. To tighten it up, you need a good narrow head flat head screw driver and slide it in sideways to the pin slot. Then push hard against the shackle to make really tight.
